European Flood Awareness System

DETAILED ASSESSMENT REPORT “THE DECEMBER 2019 EVENT IN NORTHERN SPAIN”

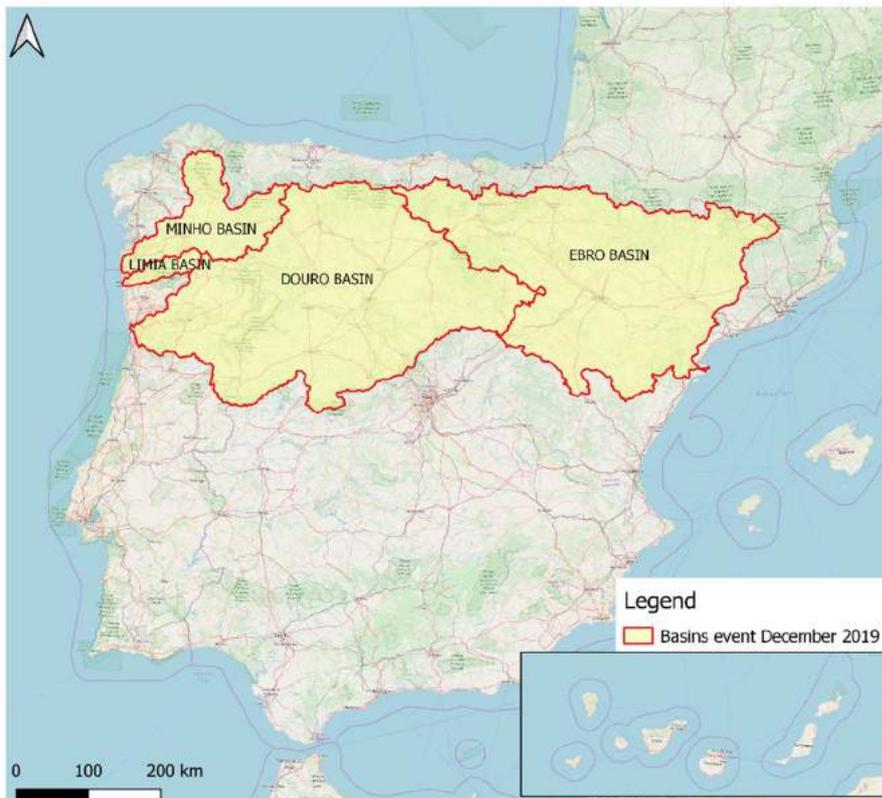
Figure 1 Map of the basins studied in this report, for the flood event of December 2019.

The study area chosen for this Detailed Assessment Report comprises of four basins located in Northern Spain: Minho, Limia, Douro and Ebro. These basins are adjacent to each other, being Minho and Limia the most western and Ebro the most eastern. Because those four basins comprise a large territory within Spain, with important differences, their characteristics will be explained separately. The basins considered for the detailed assessment are shown in Figure 1.
